VIZAG GAS LEAK- A CASE STUDY ON THE UNCONTROLLED STYRENE VAPOUR RELEASE FOR THE FIRST TIME IN INDIA

Dr Yashoda Tammineni ¹

Teja Dakuri ²

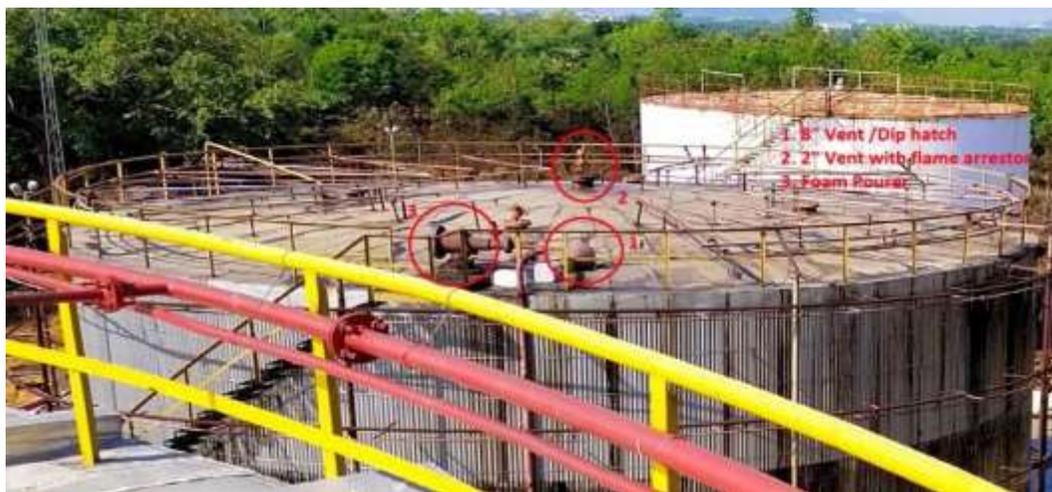
The M6 Tank is made of mild steel without any inside lining and insulated outside. It operates under atmospheric pressure and has a Flame Arrestor / Vent (N6) and a Vent / Dip hatch (N1). In addition, there is a manhole / foam pourer (N2). There are a total of 17 nozzles in the M6 Tank.

Fig 1: M6 Tank with vents on top of the tank

As the vents of the tank are open to atmosphere, emissions of Styrene are prevalent. Unlike the modern designs, the tank neither has a flare system that burns the Styrene vapours forming carbon dioxide nor did a cryogenic system to condense Styrene vapours that can be collected separately. The M6 Tank is not provided with any of the above safety systems.

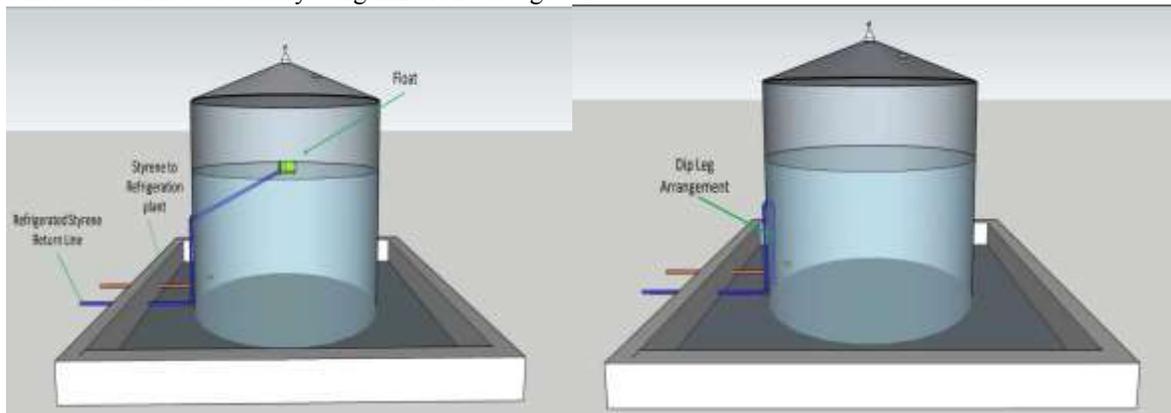
The LG Polymers management in its hearing on 7th June 2020, informed the High-Power Committee on a query that they modified the M6 Tank in December 2019 to the present design. On specific query about the changes carried out, they have further informed that the modification had not been informed to PESO or any other concerned statutory organization to get it

Fig 2: Before and after the modification of Storage tank

The modified piping design provided for the cooled Styrene return line from the refrigeration unit to the nozzle located about 300 mm above the bottom of the tank. Not only it totally disturbed the chemical circulation system, it led to significant thermal stratification in the M6 Tank with high temperature gradient. The top level of the Styrene monomers in M6 Tank experienced much higher temperatures than the bottom. On the whole this change in design, in a way, sowed the seeds of disaster.

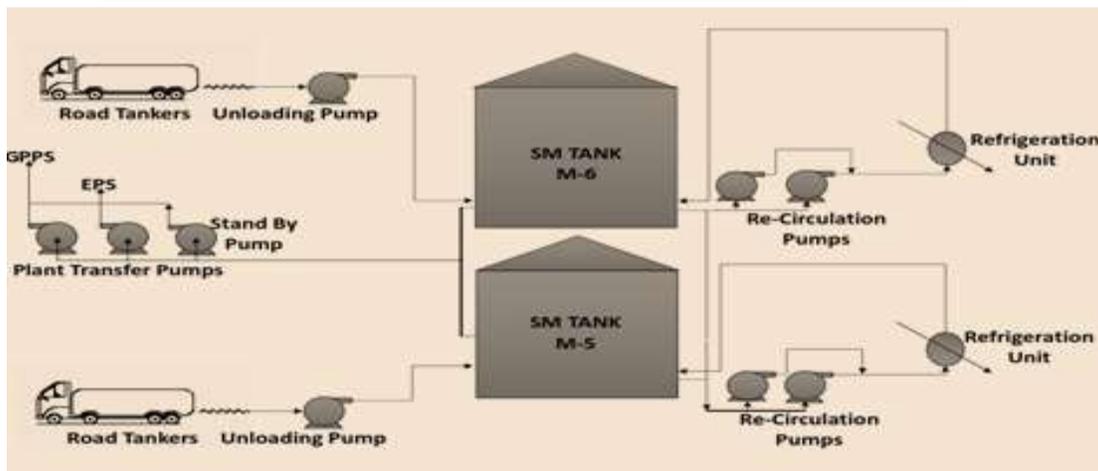
Under no circumstances the temperature of Styrene in whole tank should exceed 25°C according to the standard guidelines for Styrene storage. Hence, it necessitates maintenance of lower storage temperature in the tank. Higher temperatures are bound to cause Styrene vaporization and subsequent build-up of polymer. Usually, the preferred storage temperature is in the range of 10 – 18°C. If the temperature approaches 20°C, the tank contents must be cooled. Thus, proper refrigeration–recirculation systems need to be provided. As the tank is insulated, the exothermic polymerization heat cannot be dissipated. The M6 Tank does not have proper mixing arrangement to take care of any increase in temperature in middle and upper zones. Although the company has stated that there are temperature alarms at 35°C and 37.5°C, the temperature data recorded in the DCS on the 7th of May does not record any temperature alarm either at 35°C or 37.5°C. The Technical Committee, in its report has mentioned that there is no temperature alarm also for the M6 Tank. The temperature of liquid Styrene Monomer is a very crucial factor. The temperature maintenance throughout the large storage tanks at 15-20°C is essential in light of possibility of runaway polymerization characteristic of Styrene.

Fig 3 : PFD of Styrene Monomer Handling Plant

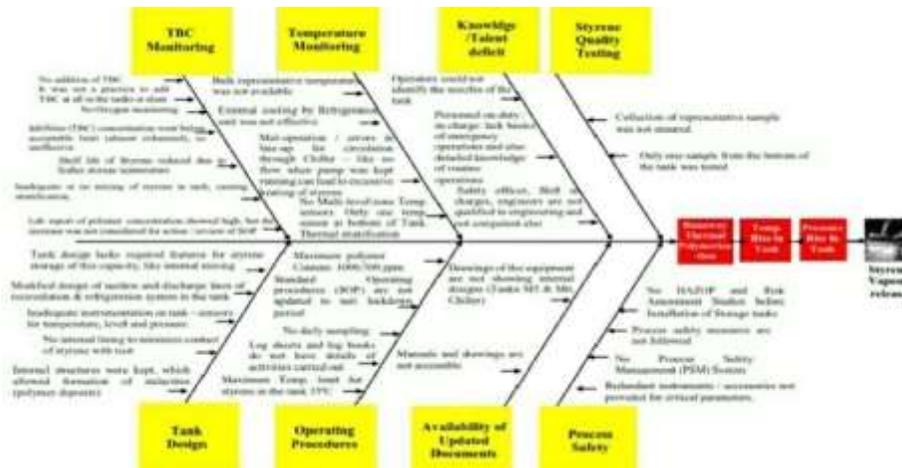
The total release of Styrene vapour up to 07:40 a.m. on 8th May 2020 is approximately 562.43 MT. The total loss of Styrene till 11:52 a.m. is approximately 818.16 MT. This is based on the assumption that 95 MT of Styrene monomer was withdrawn during the emergency response measures; otherwise the quantities will be 95 MT more. The fishbone diagram explaining the root causes is also prepared.

Fig 4: Ishikawa fish bone diagram explaining the root causes

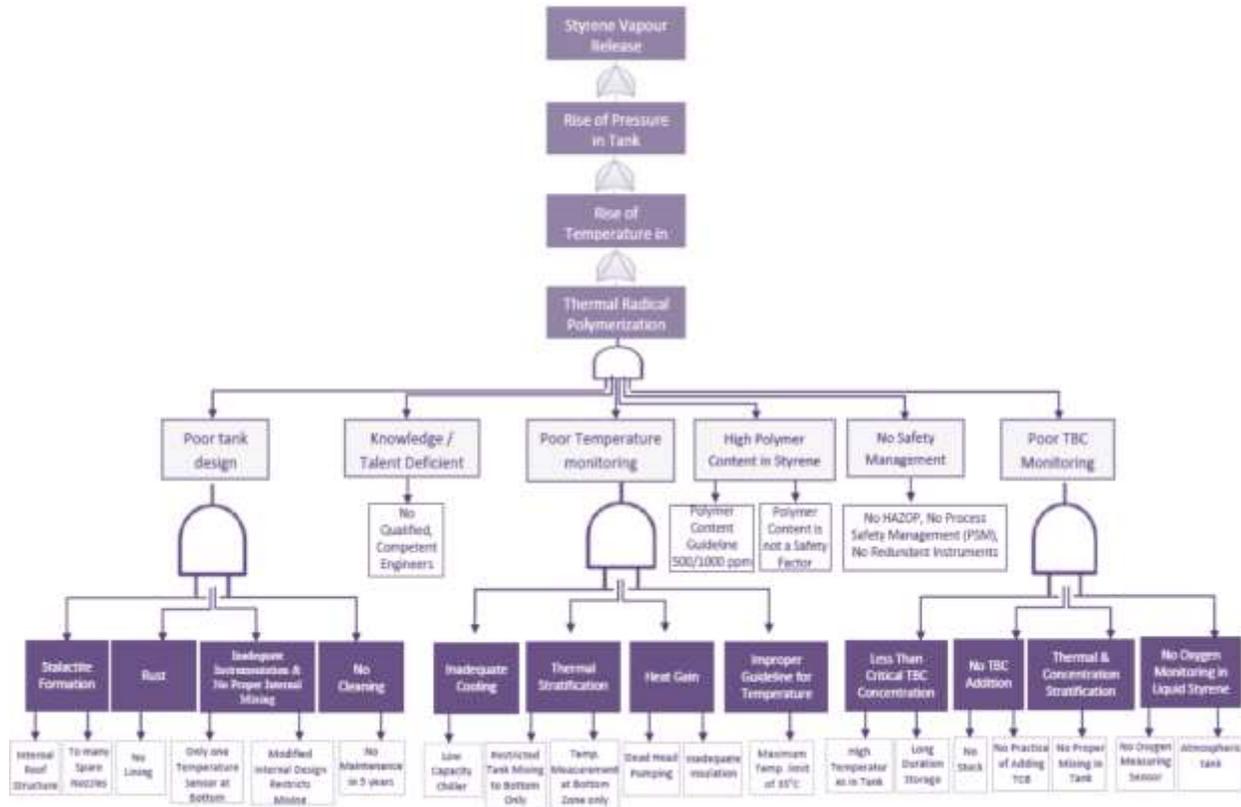
Fig 5: Fault Tree Diagram (FTD) explaining Styrene Vapor release
